# Pontes country house

## Project summary

<b>Site:</b>	<b>Lugar de Pontes Castro Laboreiro, Melgaço</b>
Altitude:	726 m
Heating degree days:	2770 (base temp. 20° C)
Owner:	Carlos Moedas
Architect:	Inês Cabral
Engineer	André Coelho Ecoperfil, Sistemas Urbanos Sustentáveis, Lda.

<b>Building description /typology</b>
– Located in a small rural village in the hills of Peneda in the northwest of Portugal
– Individual vernacular stone (granite) wall house
– Originally built in 1940
– Currently inhabitable, almost in ruins
– Gross heated area: 180 m <sup>2</sup>

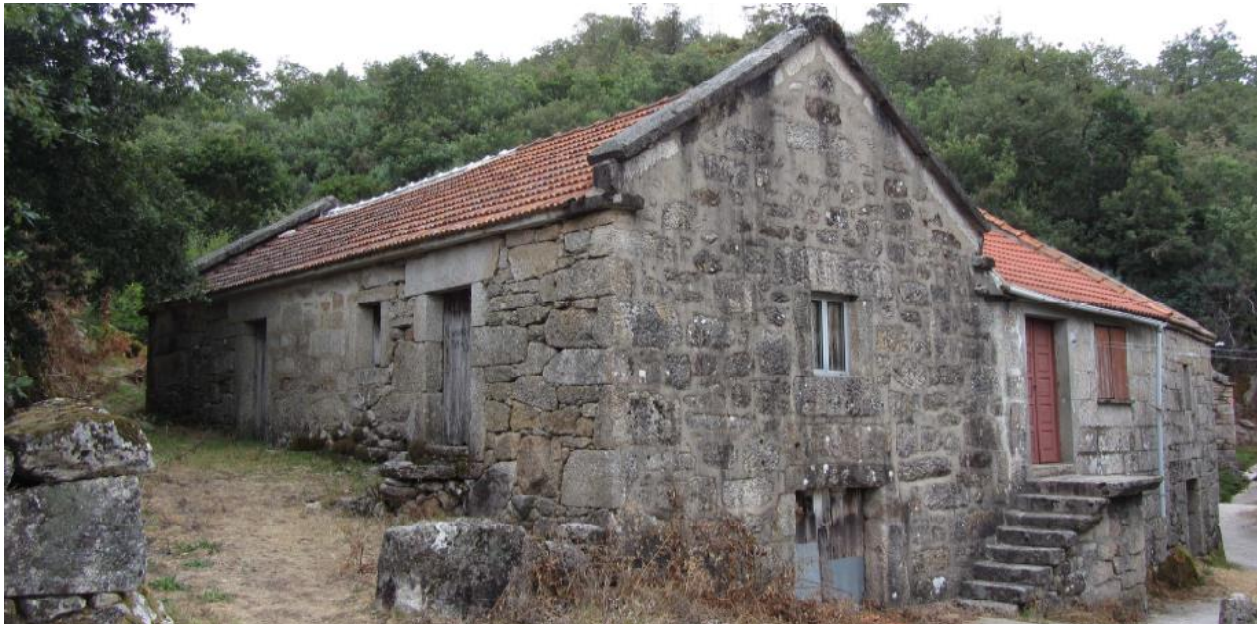
Country house before intervention (south east and southwest facades)

Uninsulated granite stone walls (without coverings), wood structure floors and roof (not insulated), ground floor in direct contact with soil (animal shelter), single glazed windows with wooden and frames (degraded). Original stone walls were massive but loosely arranged in some areas (need of structural reinforcement)

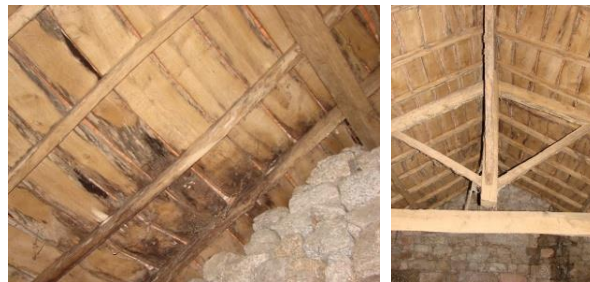
Roof condition and characteristics

- Walls: creation of an interior closed air space, placement of insulating cork boards (ICB) and light covering elements (in general MDF boards over wood support). This solution allows maintaining the existing materials and avoids new construction while preserving the external architectural identity of the building.
- Roof: wooden false ceiling, creation of closed air space, structural oriented strand board (OSB), placement of ICB, water tight covering.
- Floor: ICB under floor slab
- Windows: replacement of all existing windows and placement of new double glazed ones with low emissivity layers, within wooden frames (4+16+6 mm).

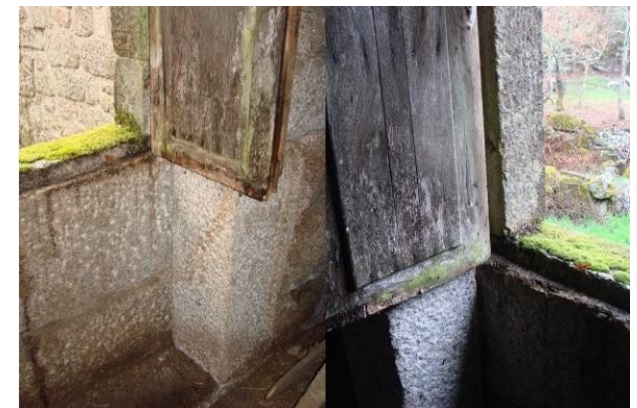
*Existing window sills*
