Sems Have, Roskilde

Project summary

Energy concept: Insulation, ventilation, PV system, heating system

Renovation and conversion of a dormitory/day-care centre into 30 low energy apartments:

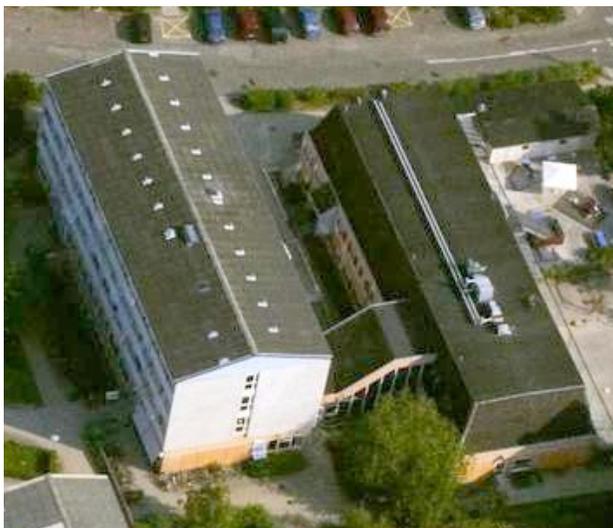
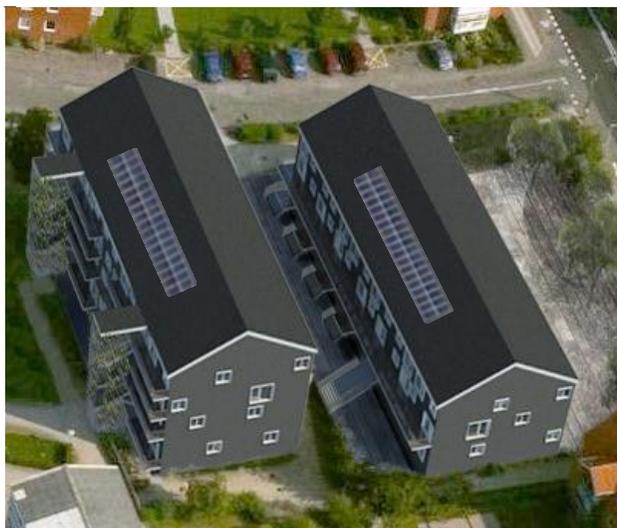
The two blocks of Sems Have before the renovation (to the left) and after the renovation (to the right).

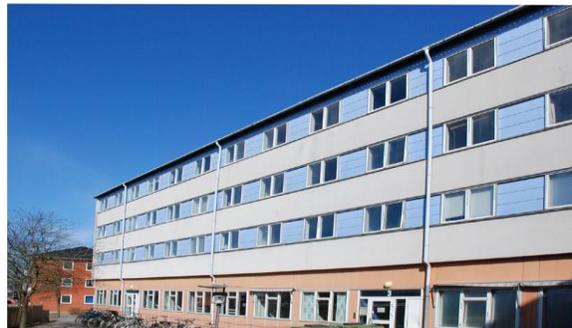
Block A before renovation

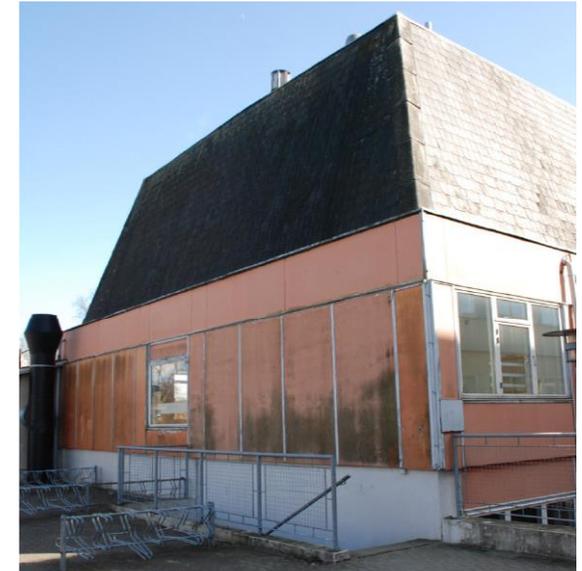
Block B before renovation.

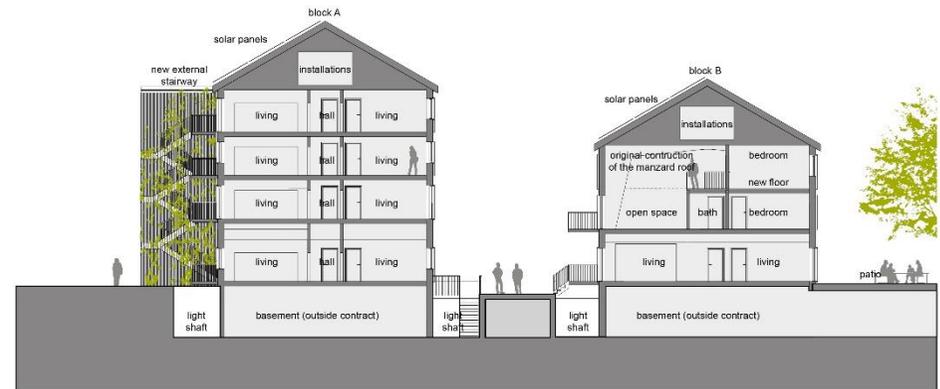
Cross section of block A (to the left) and block B (to the right) after the renovation.

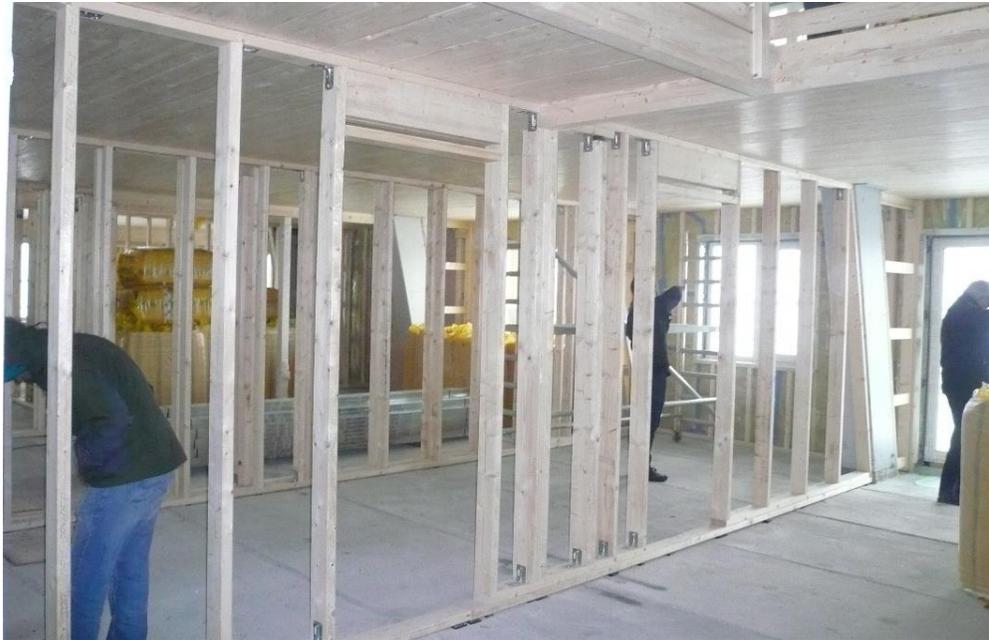
New internal walls and inserted deck at the first floor of block B.
