Maratonvägen 36

Project summary

Energy concept: To achieve a substantial reduction of the energy losses.

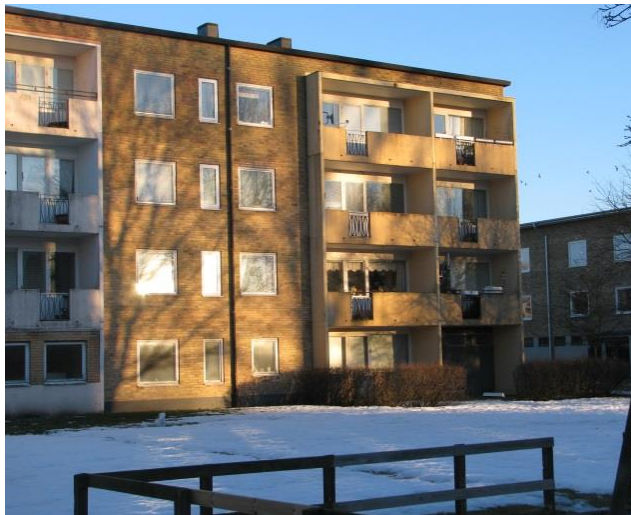
Before renovation

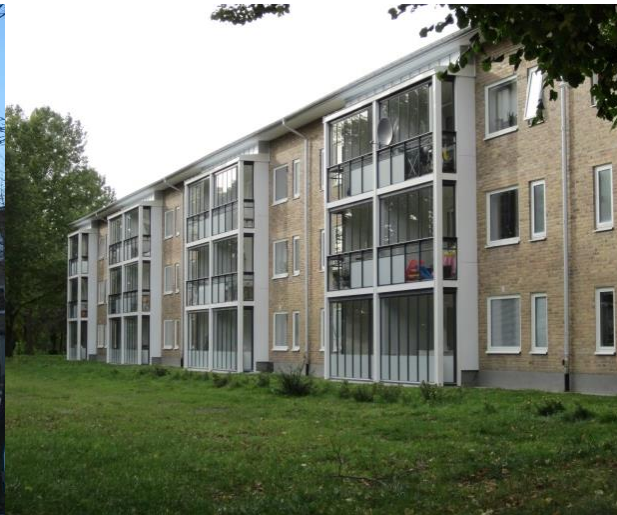
After renovation

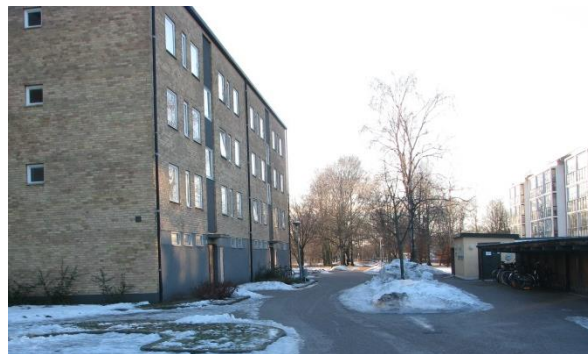
Before renovation

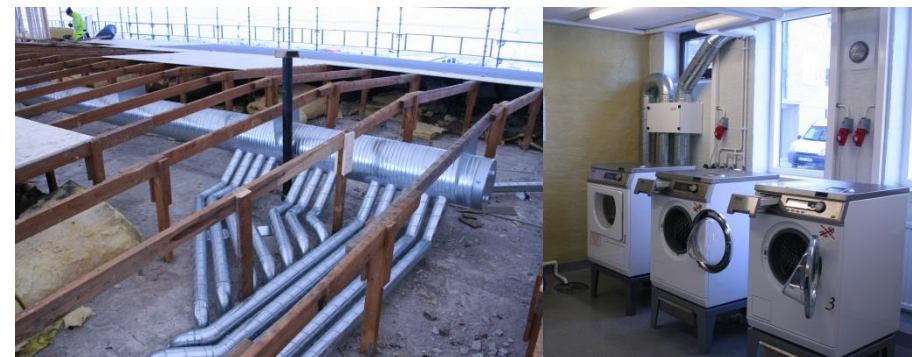
Installation of ventilation ducts in the new attic and new washing machines in the common laundry room.

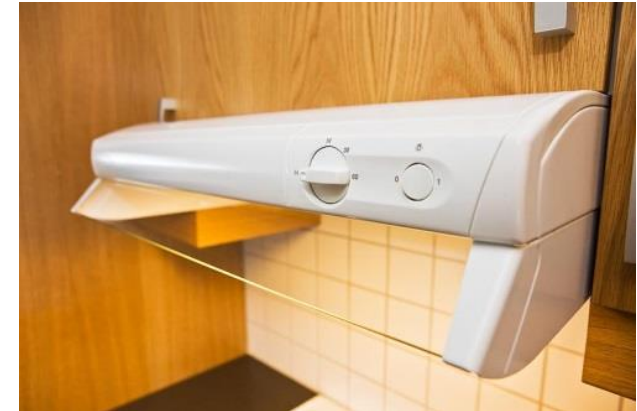
New cooker hood.

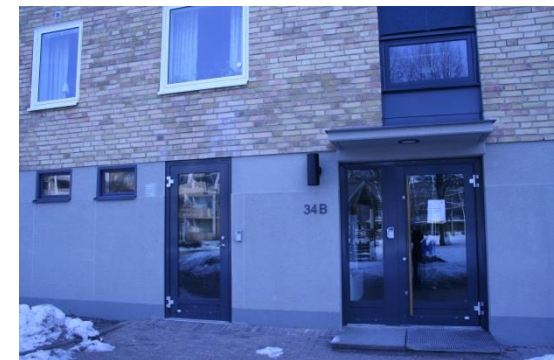
New windows and entrance

- Adding thermal insulation to the roof and the infill walls behind the balconies.
- Raising the roof from being a flat roof to a ridged roof.
- Improving the airtightness from 1.4 l/sm² to 0.5 l/sm² at 50 Pa. All apartments were tested.
- Replacing the windows with triple pane windows.

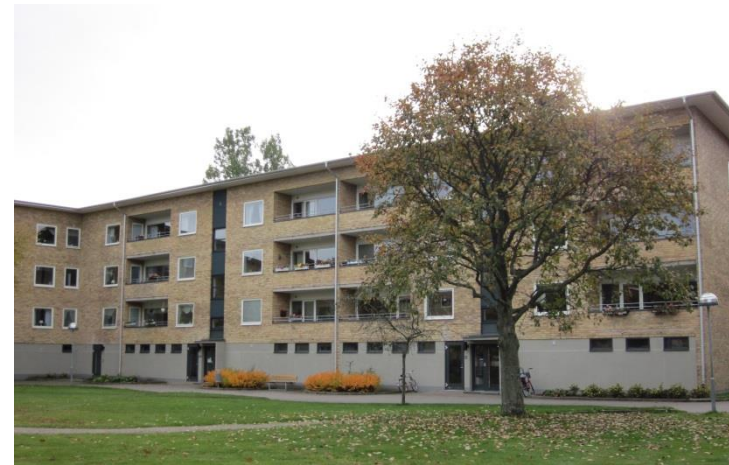
Renovated building.
