# Kapfenberg, Austria

## Project summary

**Energy concept:** Insulation, mechanical ventilation, solar thermal and PV-system

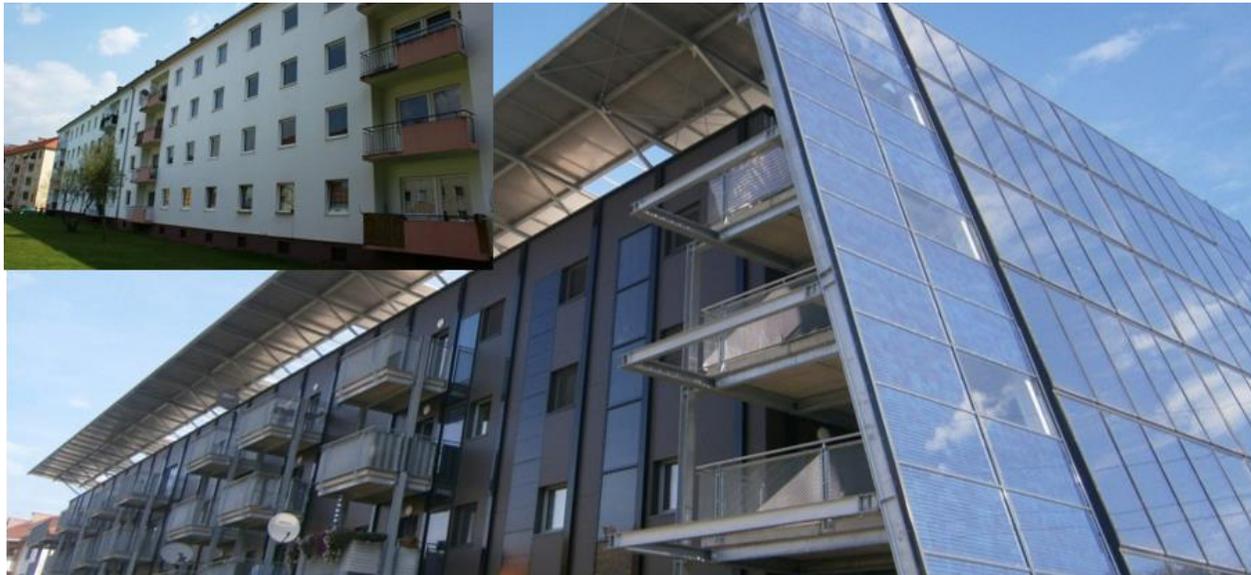
View of existing (small picture) and the renovated building (large picture) (west elevation)

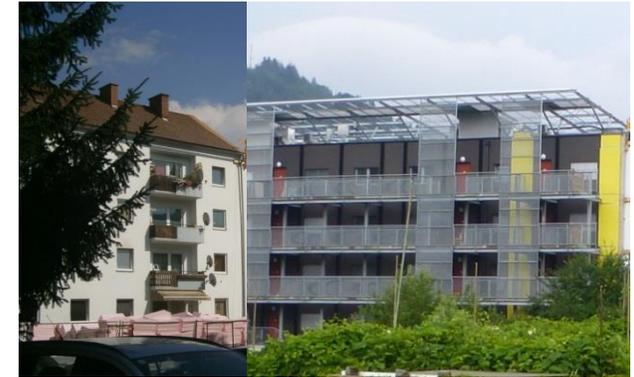
Facade – before and after the renovation

The existing building was a typical building from the 1960's made of prefabricated sandwich concrete elements without an additional insulation. Only the wood wool panels of the prefabricated concrete elements performed as a slight thermal insulation.

The existing windows were double glazed windows with an U-value of 2.5 W/m<sup>2</sup>K. The missing airtightness of the existing windows caused high infiltration losses.

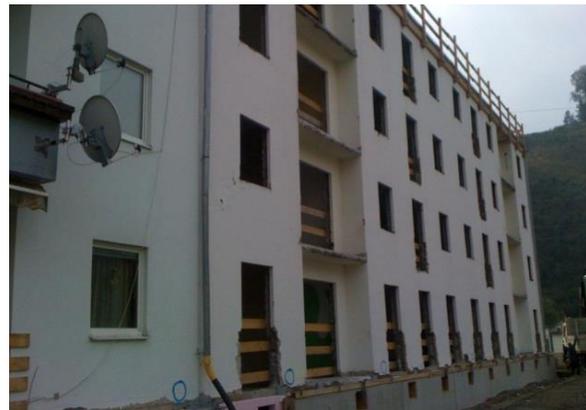
Facade during the renovation

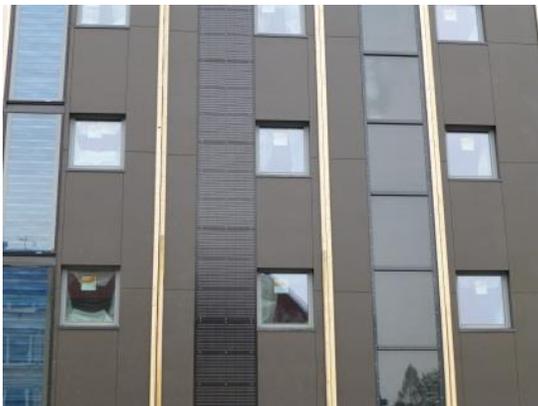
*Prefabricated façade elements with integrated active energy production (photovoltaic and solar thermal panels)*

Instead of conventional insulation systems the façade in this project is covered with large-sized active and passive façade elements.

These façade elements include on the one hand traditional rear-ventilated constructions (various surfaces possible) and on the other hand active elements to produce energy like solar thermal or photovoltaic panels.

The old pitched roof is removed and a new flat roof is established. The roof is highly insulated with approximately 35-40 cm. The windows are already integrated in the prefabricated façade modules and are of high thermal quality (triple glazing).

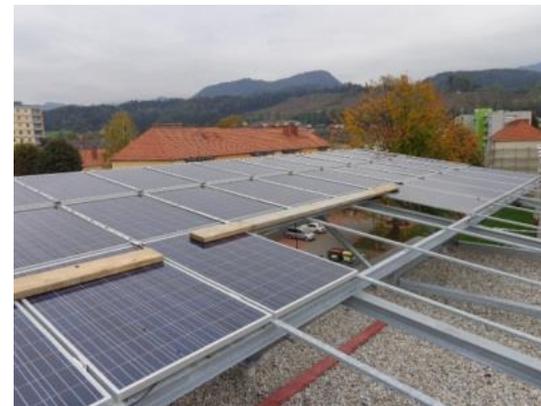
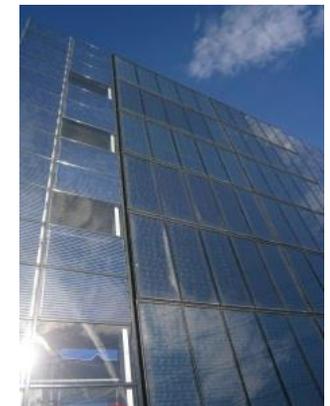
*Mounting of the photovoltaic panels on the roof (left picture), pv and solar thermal panels on the south façade (right picture)*

**Photovoltaic:** Photovoltaic panels with a size of 550 m<sup>2</sup> resp. 80 kWp are installed on the roof on a steel construction in form of a wing. Additionally 80 m<sup>2</sup> resp. 12 kWp are installed on the south facade.

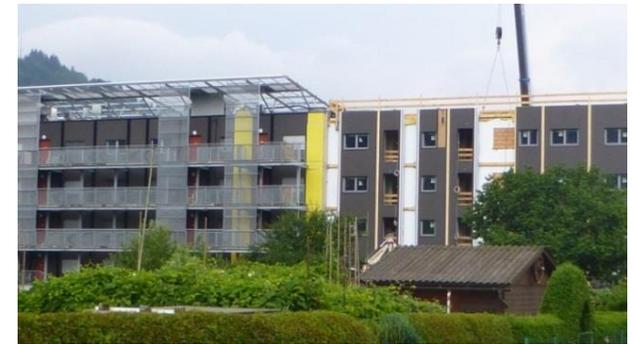
*Left building part already renovated – right building part in the middle of the renovation*

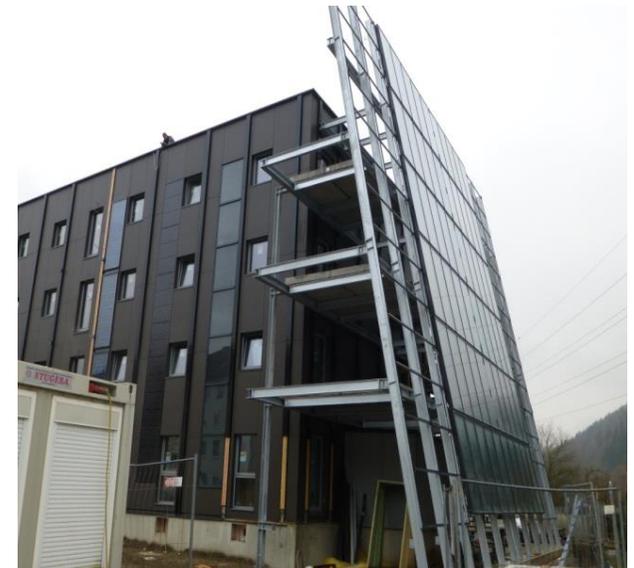
*Solar thermal and PV panels on the south facade*

**Heating:** The basic heat supply of the renovated building is accomplished by the local district heating. Additionally 144 m<sup>2</sup> solar thermal panels are installed on the south facade. Heat provided by district heating and solar thermal system is stored in a 7500 liter buffer storage. From the buffer storage a 2-pipe-system (flow and return) brings the heat to the 32 flats where the heat for domestic hot water is stored in a small boiler. Radiators emit the heat in the flats.

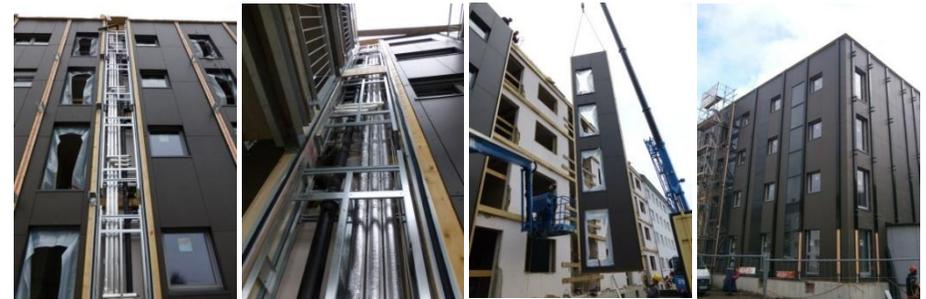
*Different steps of the building renovation process: installation of the building services, assembling of the prefabricated façade modules, almost finished building envelope (f.l.t.r.)*

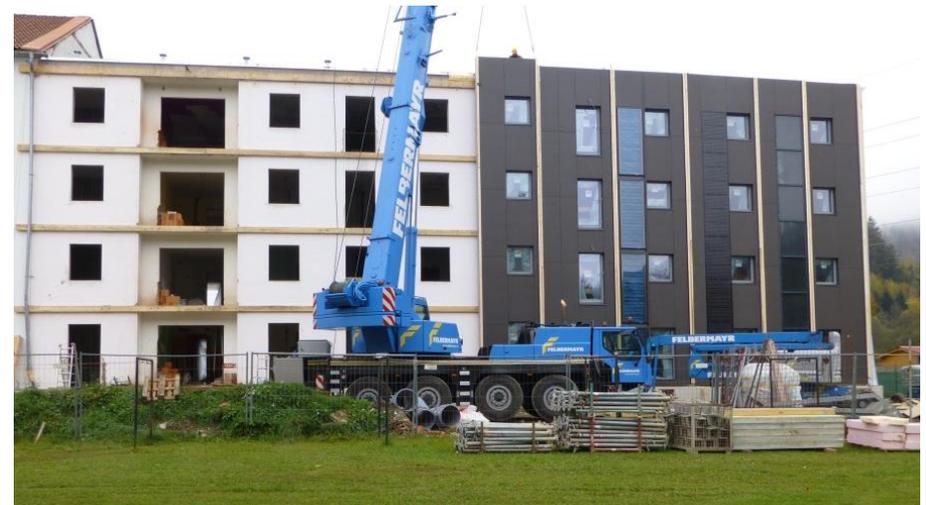
*Assembling of the prefabricated façade modules on the west facade*

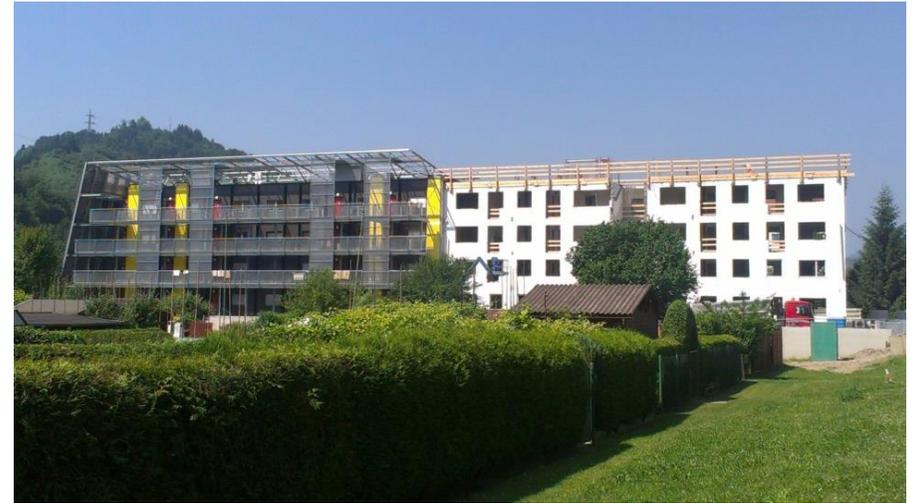
*Left building part: finished renovation; right building part: still in renovation*

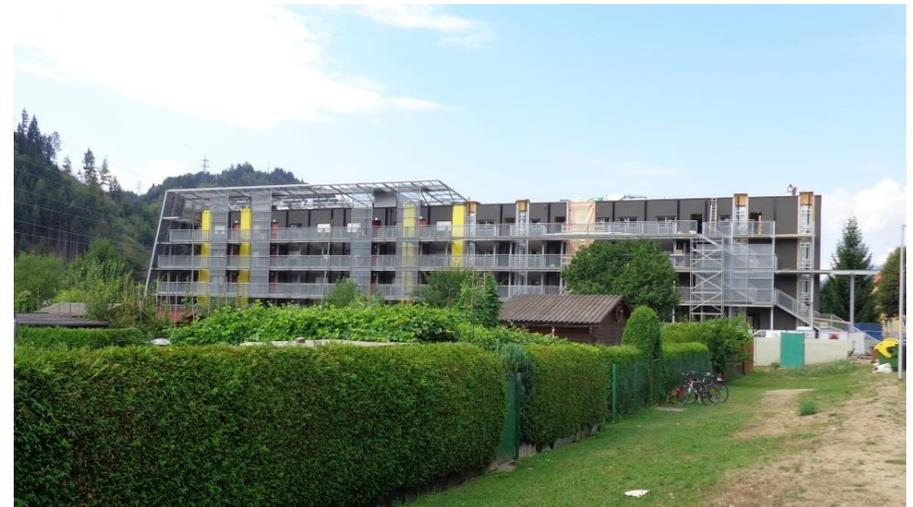
*A few days later – building envelope of the right building part almost finished*
