# Brogården, Alingsås

## Project summary

**Energy concept:** Renovation using passive house technologies.

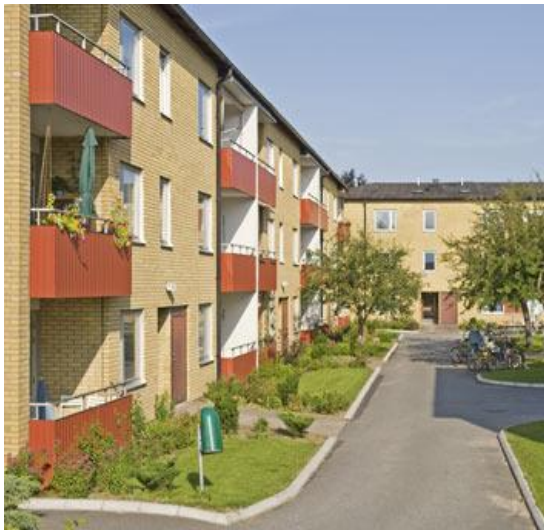
*Before renovation.*

The buildings are typical for the seventies with a concrete structure and in fill wall. Walls consisted of gypsum boards on non loadbearing wooden studs, 95 mm insulation and façade bricks. Basement: cast-in-situ concrete walls were without any insulation. There was 300 mm insulation on roof slab and wooden rafters with props on roof slab. The windows were single pane with supplementary aluminum sash and one additional pane.

The apartments were perceived as drafty and had a poor indoor thermal comfort due to leaky façades. The balconies constituted thermal bridges. The façade bricks were partly destroyed by moisture.

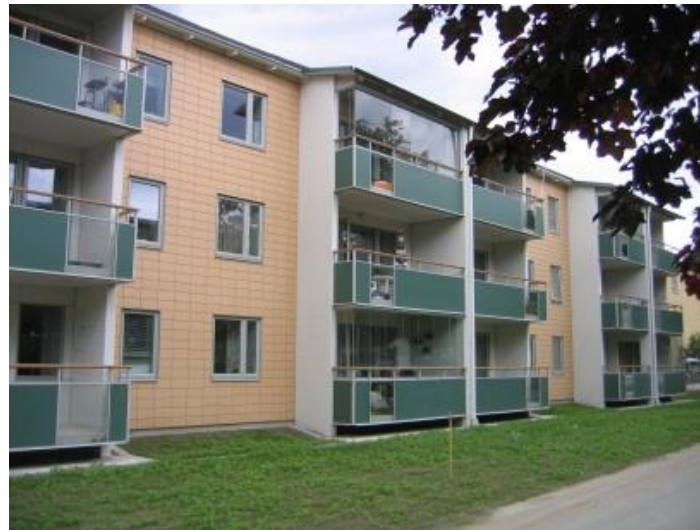
*After renovation.*

The renovation was necessary due to wear and tear. The results were substantial improvements in the standard of the building and at the same a substantial reduction (60 %) in energy use, while keeping a similar architectural appearance. This was done using traditional building materials and with common contractors. The energy savings were estimated to be paid back in 17 years. The planning process was very long in this demonstration project. The energy aspect was for a long time not considered important. The conclusion is that comprehensive efficient project management is needed and that energy has to be included from the beginning. All necessary competence has to be involved from the very start of a renovation project.

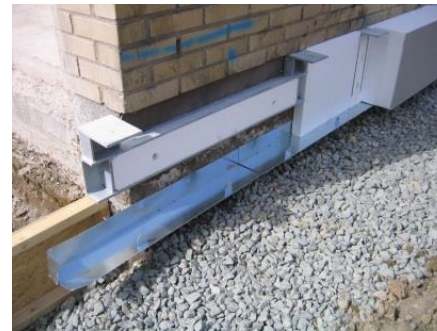
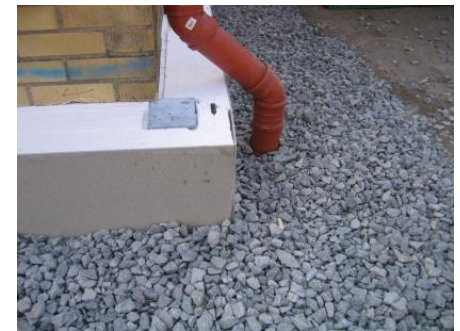
Added insulation to the foundation

Element	After renovation
Exterior walls	Altogether 480 mm thermal insulation. Adding 430 mm of thermal insulation to the gables
Roof	Adding 400 mm of thermal insulation to the roof
Base plate	Adding 60 mm of EPS
Windows, average	Triple pane
Doors	New doors

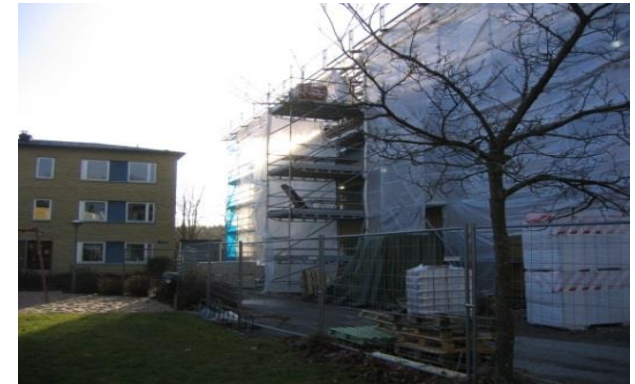
*During reconstruction the building was covered by a tent.*

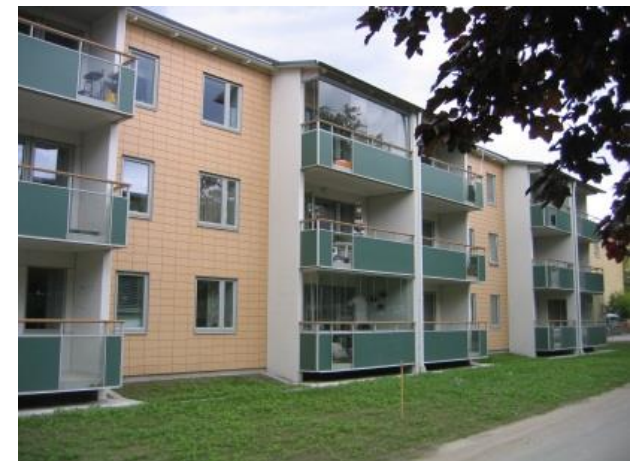
*Nice looking buildings with new balconies*

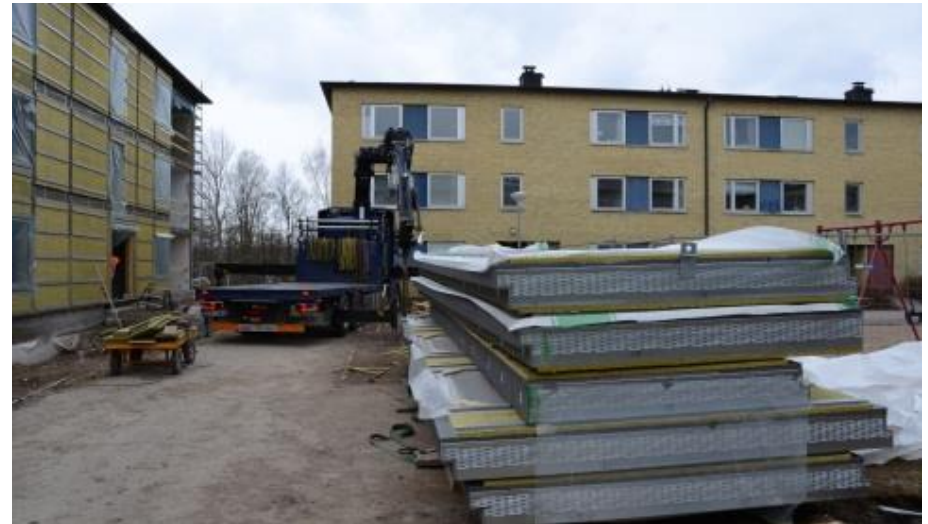
*Prefabricated facade elements for the next phase of renovation.*

Central ventilation heat recovery on ventilation should be used instead decentralized, to reduce maintenance work and work changing filters. The façade construction should be simplified from a four layer on-site construction to a two layer construction with insulation, to reduce investment costs and simplify the production. For the following buildings (150 apartments) prefabricated façade elements are used for renovation.

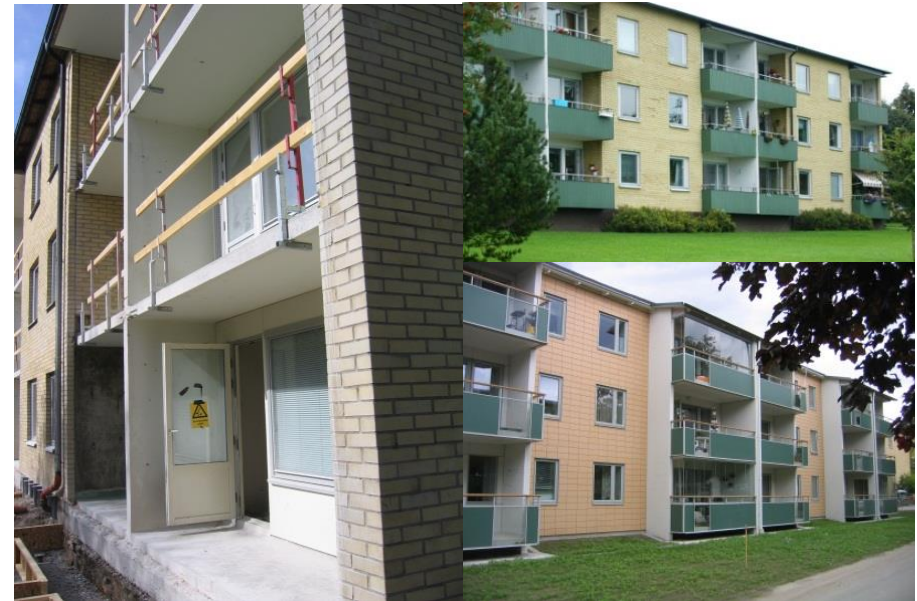
*Long side façade with balconies before (left and above) and after (below) renovation.*

- Replacing the infill walls with well insulated new facades.
- Adding thermal insulation to the gables, the roof and the base plate.
- Improving the airtightness from 2 l/sm<sup>2</sup> to 0.2 l/sm<sup>2</sup> at 50 Pa.
- Replacing the windows with triple pane windows.
- Incorporating the balconies with the living rooms to eliminate thermal bridges and building new balconies supported by columns.
- Individual metering of household electricity.
